Field Report for Airborne Data Collected In Support of US EPA Region 6 Intercontinental Terminals Company LLC Fire 15 April 2019

Data Results Flight 26, 15 April 2019

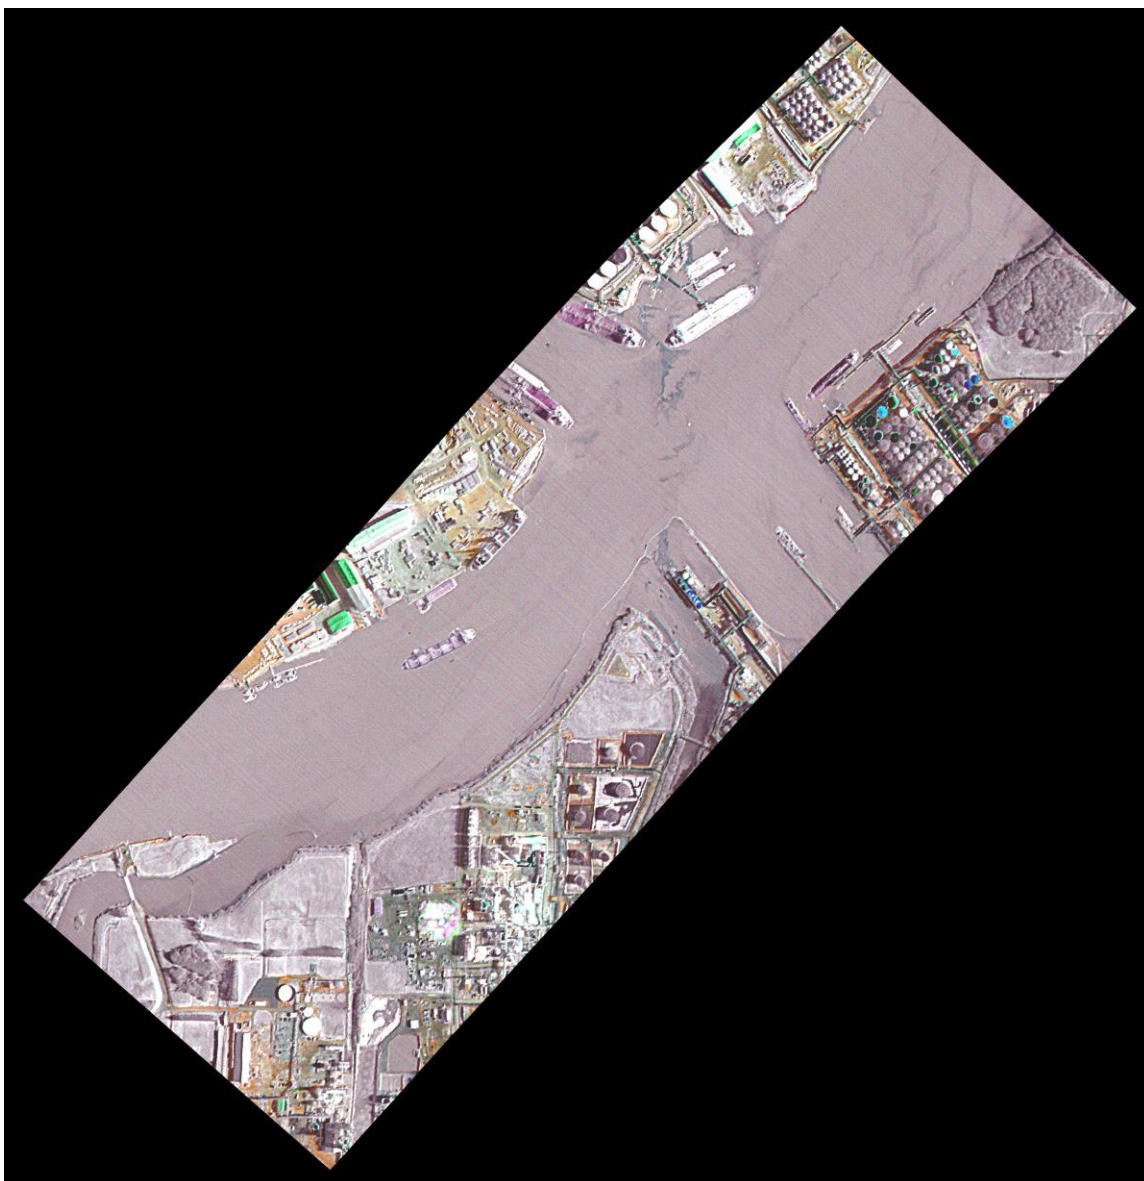
The confluence area is shown in Figure 4. Examination shows similarity to the imagery collected on 14 April 2019 namely that the channel water is relatively warm. The dark signature in the channel behind the ship is likely cooler water from the prop wash. Little

if any product is observable in the image. In addition, no sheen or leakage is evident in the image.

Figure 4: IR Image of Contained Oil 15 April 2019, Flight 26, Run 6

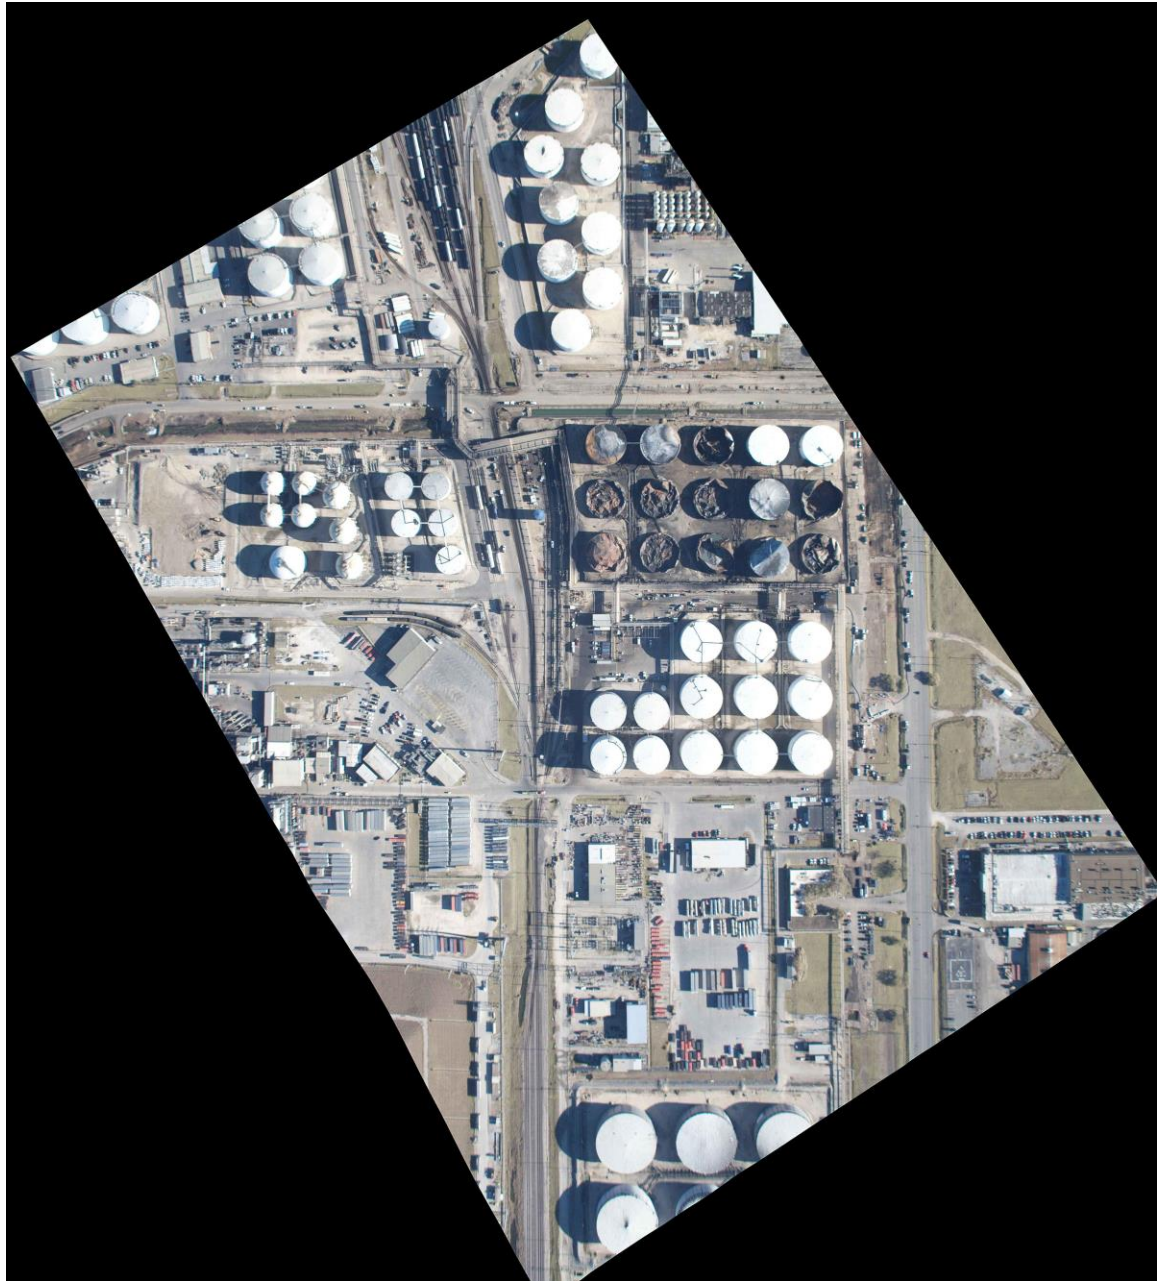
A full set of high resolution aerial digital photography was collected as part of the flight. Figure 5 shows representative overhead images collected as part of each pass over the tank farm. Examination of the image shows no change from data collected on the previous flight. A similar conclusion is reached based on the oblique imagery (Figure 6).

Figure 5: Aerial Image of the Tank Farm, 15 April 2019, Flight 26

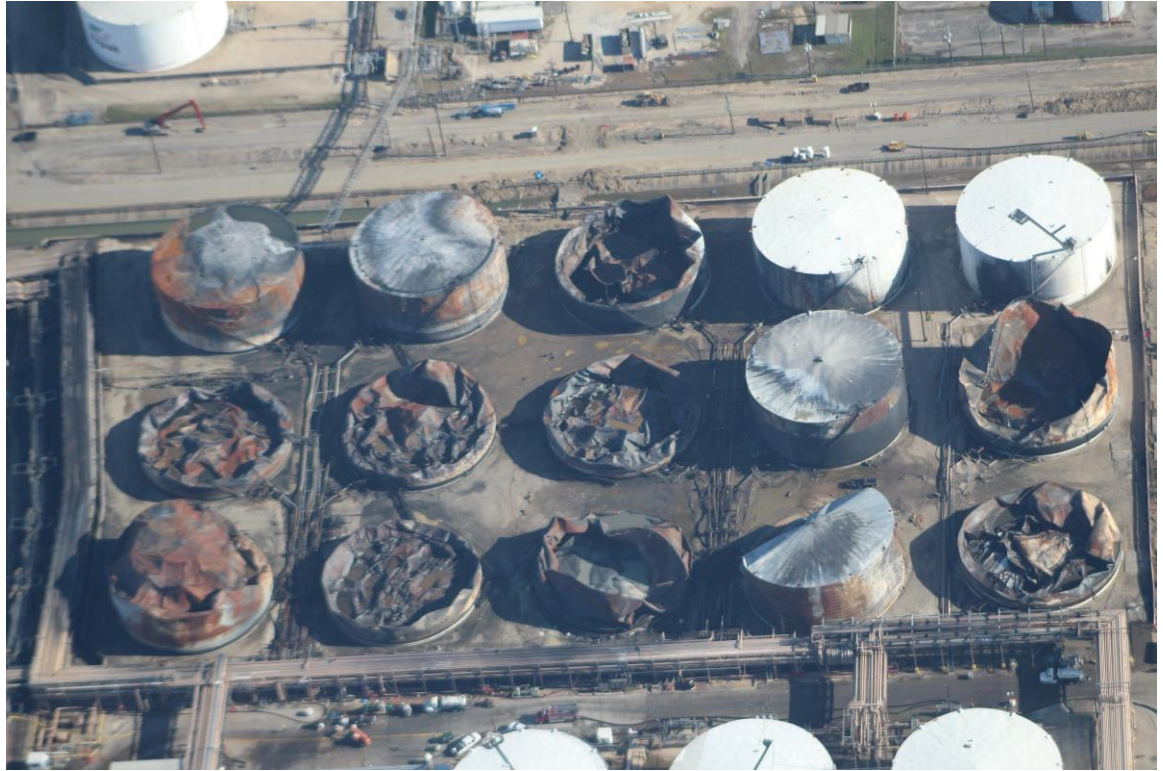
Figure 6: Oblique Image of the Tank Farm (looking toward the North), 15 April 2019 Flight 26

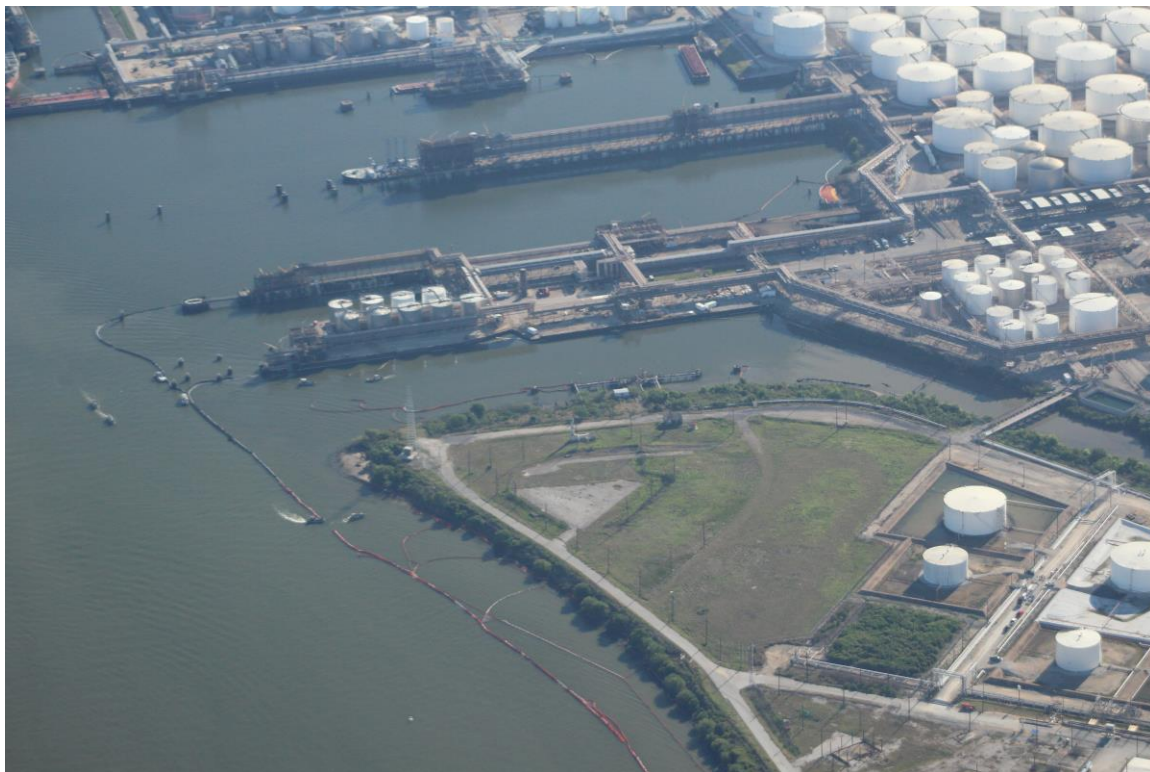
Figure 7 shows an overhead aerial image of the boomed area along the ship channel. A small dark area is present extending from the point of the drainage channel. Examination of this area and the same area shown in the oblique (Figure 8) suggest this is a shadow from a tower located near the shore and not product. No sheen is visible in either image perspective.

Figure 8: Oblique Image of the Ship Channel Boom Area, 15 April 2019, Flight 26
